REPORT OF THE INVESTIGATING COMMITTEE
CPP WASTE TANK WM-187 LEAKAGE
OF
MARCH 17, 1962

J. W. Latchum, et al

April 17, 1962

PHILLIPS
PETROLEUM
COMPANY

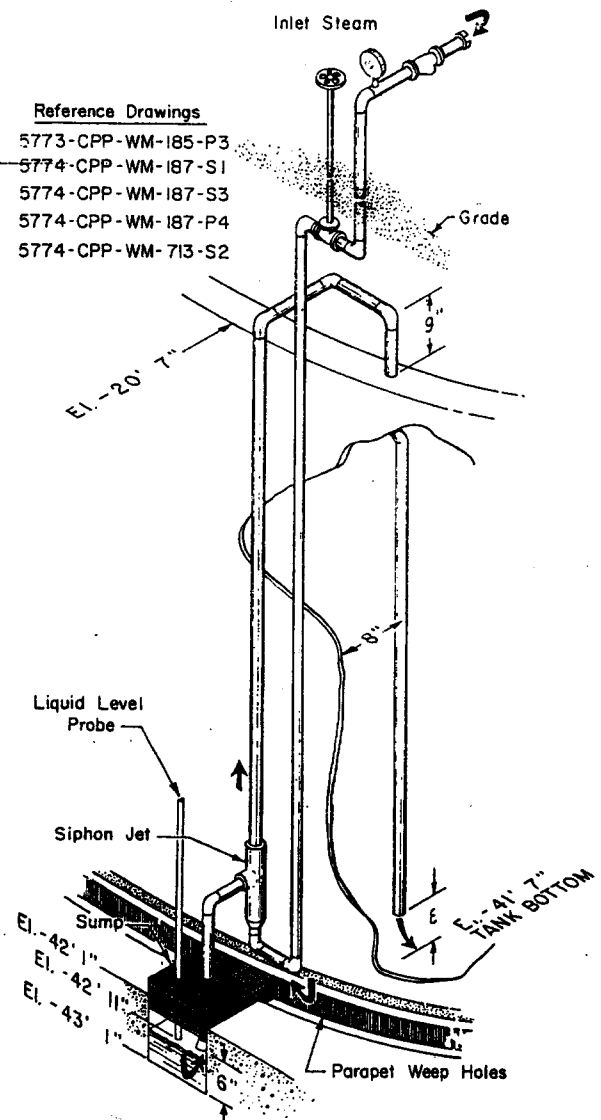
SUMP JET ISOMETRIC

There are actually two sets of sump piping on WM-187, a typical 300,000 gallon first cycle waste tank, which could act as siphons. The purpose of each set is to transfer waste which may get into the vault back into the tank. A brief description of each system is as follows (Exhibit 2). A steam jet takes suction from a one-foot square by one-foot deep sump and discharges to the inside of the tank. The 2 inch schedule 80 pipe from the jet is routed up the outside of the tank wall thence through the tank roof and down the inside of the tank wall. The pipe terminates eight inches from the tank bottom.

2. The six most recently constructed storage tanks are equipped with jet siphon discharge lines which go down to within eight inches of the bottom of the tank. The jet discharge piping, which constitutes a siphon, is not equipped with a vacuum breaker in the case of WM-185 through WM-188, although tanks WM-182 through WM-184 may be, as it was requested after a field check review of the facilities by Phillips Petroleum Company. We do not know if these were installed. This original piping is poorly designed in that the dip leg must be vented through the steam supply line each time as soon as jetting is completed. As designed these jets are sensitive to maloperation.

(1) Provide a $\frac{1}{4}$ inch hole in the downcomer leg of the jet discharge line inside the tank above the high level line. A hole of this size could not pass enough air or vapor to cause a serious contamination incident.

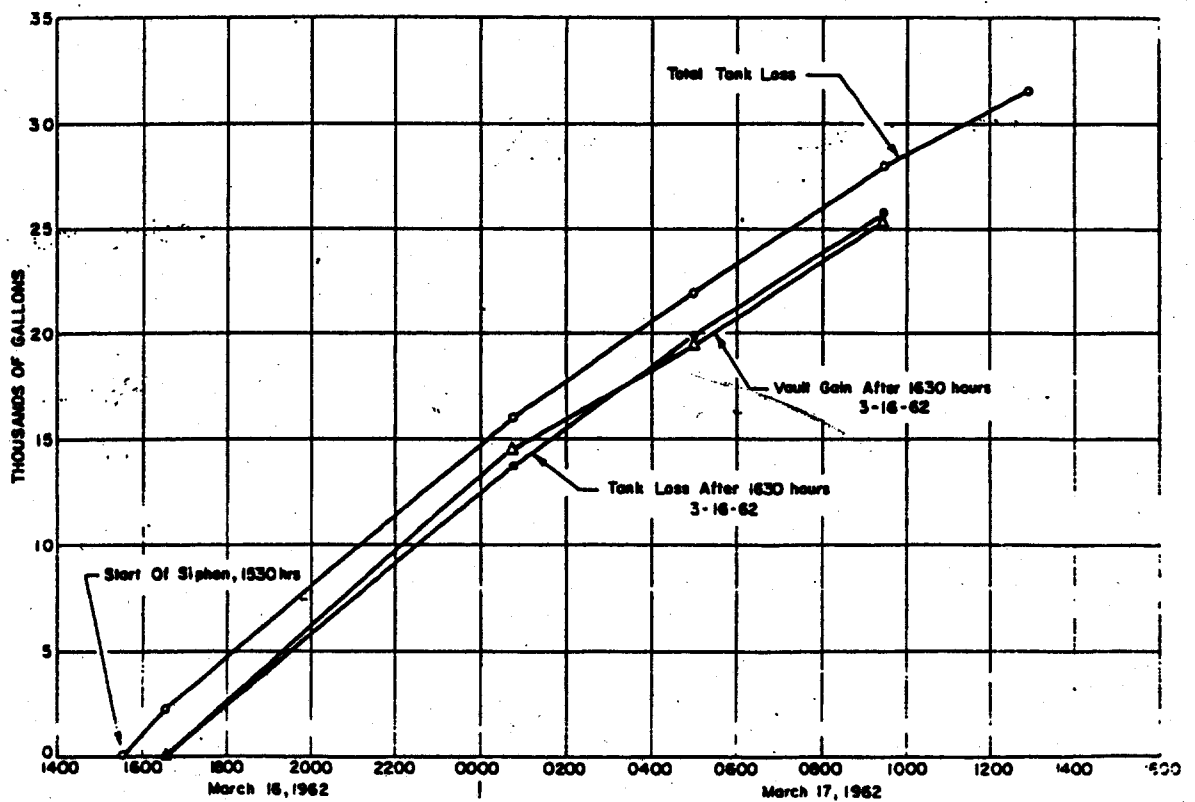
WM-187 Loss in Tank Contents
(& Comparative Tank Loss-Vault Gain)
During Siphon Period

Once the siphon was established it operated according to the energy balance stated by Bernoulli. The energy source was the difference in fluid head between tank interior and the vault. It can be shown from the data that equilibrium was not reached. Approximately 31,700 gallons were measured as leaving the tank which represents a level change in the tank of about 2 feet. The vault strapping is estimated at 730 gallons per inch. Not counting ground water in-leakage the vault level would have risen about $3\frac{1}{2}$ feet above the vault floor. This is approximately $2\frac{1}{2}$ feet of fluid short of equilibrium. An attempt was made to calculate the amount of the leak independently, using the head conditions at the start of the incident, that could be expected through one sump jet line on tank WM-187. It was calculated at 38,200 gallons over a period of twenty one and one half hours compared to the actual volume of 31,700 gallons during the same time period.
